TRIMLUX™

Product Guide

Movement seals for shower trays and baths.

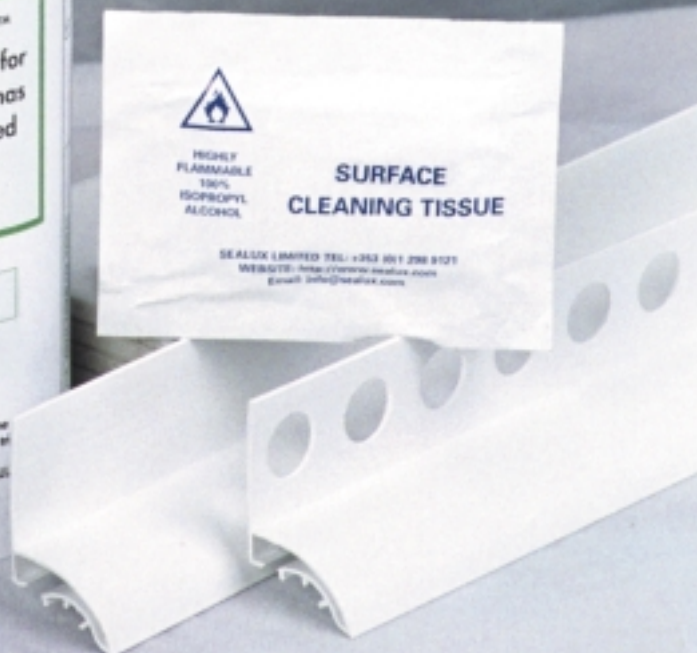
To install TRIMLUX the trim is turned upside down the trim cavity (a) under the inner leg is slightly over filled with silicone. The trim is then installed over the joint as shown below.

When joint movement occurs (refer to drawing below) to the silicone fixes the inner leg to the ledge while the flexible curved outer leg accommodates some degree of joint movement.

TRIMLUX is a two part sealing system that combines a TRIMLUX trim with TRIMLUX-N or SEALUX-N silicone. Each trim has an inner leg adapted to provide a secure fixing for silicone.

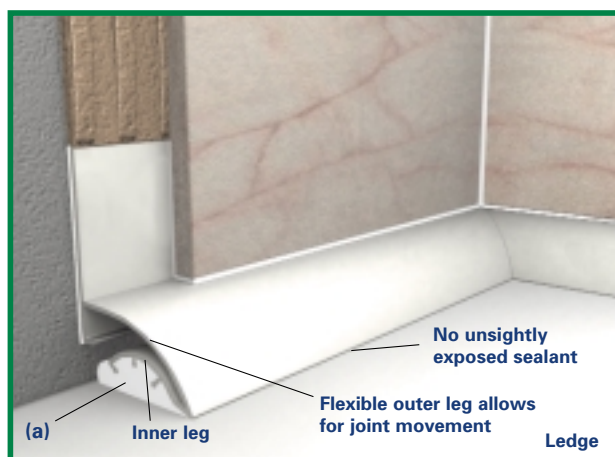
TRIMLUX accommodates some degree of joint movement through the flexibility of the profile.

A further benefit of our invention is the silicone remains out of sight, concealed and protected inside the trim.

Unlike conventional pressure sensitive sealing strips and exposed sealants TRIMLUX is a flexible, durable and hygienic sealing system.

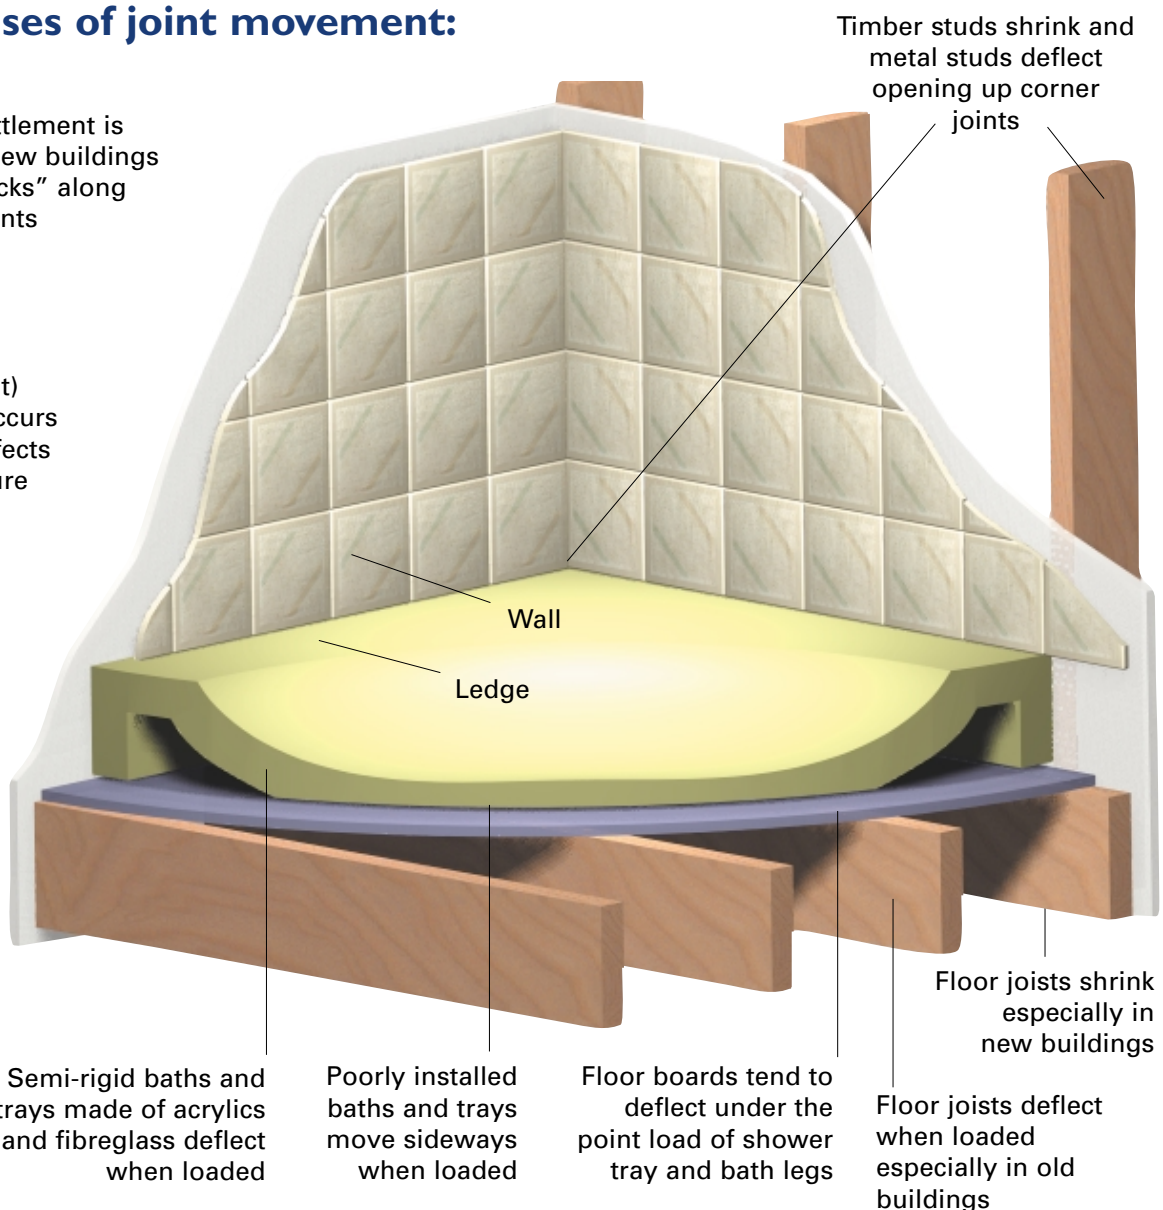
Seals must be flexible to accommodate joint movement between the shower tray or bath ledge and the adjacent walls.

The causes of joint movement:

Structural settlement is common in new buildings creating "cracks" along wall/ledge joints

Thermal (joint) movement occurs due to the effects of temperature fluctuations
